Manhole Inspection Summary

Manhole # S29I__043MH

Insp Date: **4/6/09 9:42 AM**

Location Address: **100 Penn**

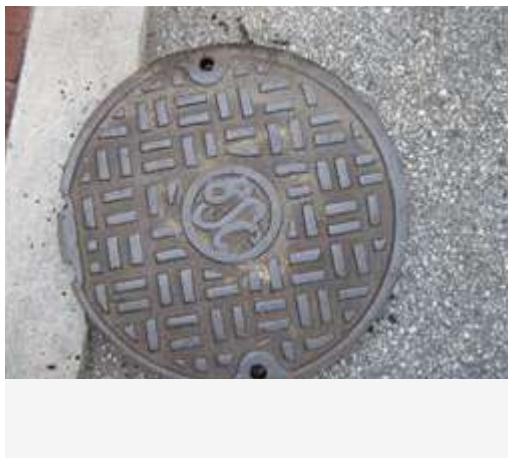
Cover View

Condition: **Sound**

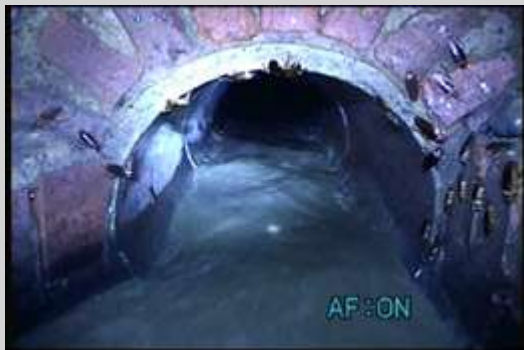
12 O'Clock Outflow

10 in. Circular Gravity Sewer
Pipe Out @ 12 O'Clock

Pipe Height: **14.4** (in.) Rod and Bar (Angled)
Pipe Material: **Clay** ☐ Pipe Lined
Invert Depth: **12.28** (ft.) Flow Characteristics: **Turbulent**
Deposits: ☒ None ☐ Mud ☐ Sludge ☐ Debris ☐ Grease
Silt Depth: **0** (in.) Deposits Extent:
Infiltration: **None** Pipe Seal Cond: **Sound**

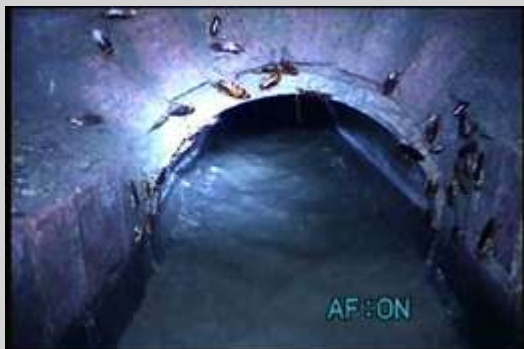
6 O'Clock Inflow

12 in. Circular Gravity Sewer
Pipe In @ 6 O'Clock

Pipe Height: **13.2** (in.) Rod and Bar (Angled)
Pipe Material: **Clay** ☐ Pipe Lined
Invert Depth: **12.28** (ft.) Flow Characteristics: **Turbulent**
Deposits: ☒ None ☐ Mud ☐ Sludge ☐ Debris ☐ Grease
Silt Depth: **0** (in.) Deposits Extent:
Infiltration: **None** Pipe Seal Cond: **Sound**
